# La Posada Hotel Fire McAllen, Texas (February 25, 1987)

Investigated by: Jeffrey M. Shapiro, P.E.

This is Report 001 of the Major Fires Investigation Project conducted by TriData Corporation under contract EMW-88-C-2277 to the United States Fire Administration, Federal Emergency Management Agency.

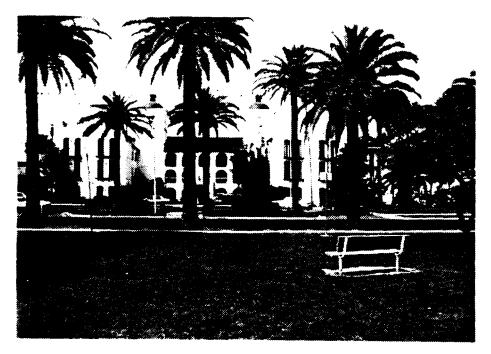
Figure 1. La Possada Hotel (view of the east end main entrance).

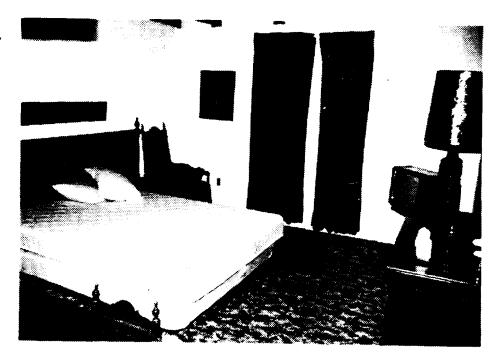
Figure 3. guest room identical to room of origin. Note exterior window and contents.

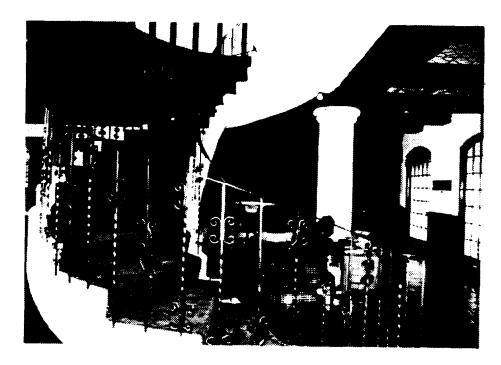
Exiting from the guest rooms was through interior corridors or through an operable window in each room. (See Figures 2 and 3.) The building has four interior exit stairways all of which are unenclosed or inadequately enclosed, based upon the criteria for new and existing hotels contained in NFPA 101, Life Safety Code. (See Figures 4 and 5.)

Figure 4. Main entry foyer. The front door-is to the right. The wall in the rear of the picture was erected after the fire to separate the damaged area. During the fire, smoke traveled past the front desk (visible in the lower portion of the wall behind the telephone operator) and up the "grand" stairway to the upper floor corridors.

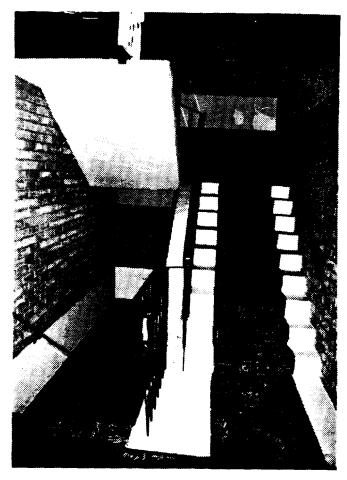
Figure 5. Typical open stairway (view from second floor corridor).

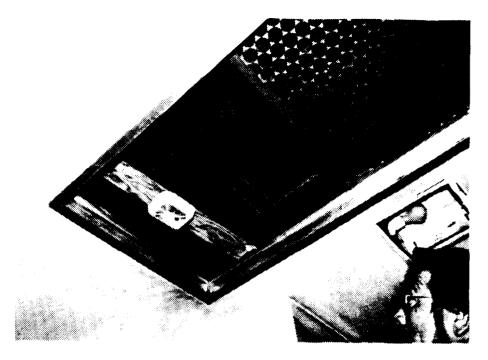
Ironically, the detector was not properly located. It had been installed (as had the other guest room detectors) in the return air plenum, rather than on the ceiling of the room. Moreover, the detector was a battery-operated type, not hard wired to the electrical system as is preferred for this type of occupancy.

Figure 7. Battery powered smoke detector in adjacent room. All detectors were located in return dir plenum above filters and grilles in ceiling.
